TrackSTAR® Holland's Loaded- Gauge Geometry Vehicle

RMSS White Paper Series

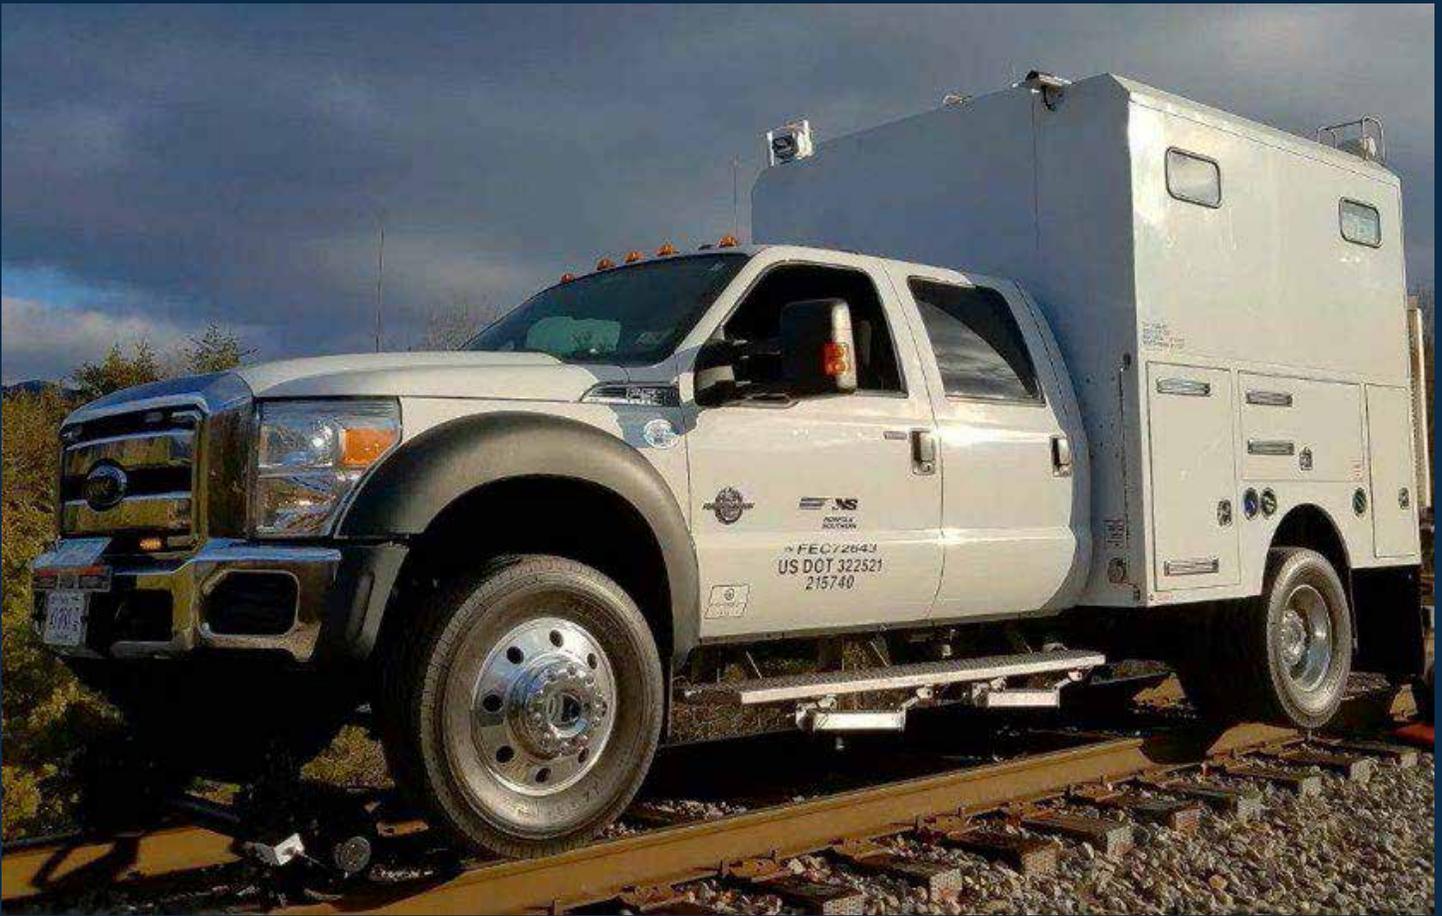
The NS 02 (850-series TrackSTAR® vehicle) will be used systemwide to identify broken spikes.

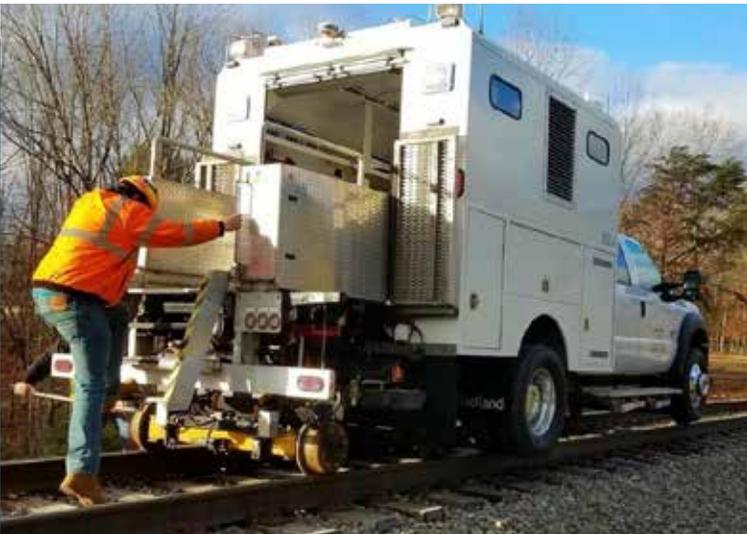
One operator is able to set up and operate the Argus® track geometry system and mini load axle on the NS 02.

The NS 02, which is equivalent to the Holland TrackSTAR®600 and 850-series hi-rail geometry car, requires one operator. It is equipped with Holland's patented Argus® system, which measures and calculates geometry parameters and generates exceptions in real time. The Argus® rail profile measurement system, which includes a laser and two cameras in each of the four modules (one each for the gauge and field sides of each rail), captures the rail shape and measures wear, cant, rail-head slope and other rail-related parameters. The Argus® system's dual camera configuration reduces the need for sun shields and provides redundancy. If one camera should fail the other camera will continue to collect data with the same level of effectiveness without interruption until repairs are made.

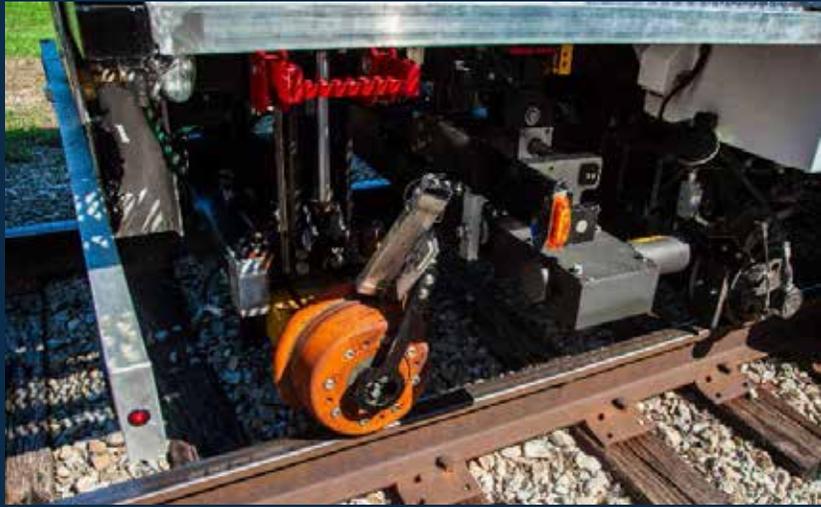
The load axle on the NS 02 generates a consistent 2,500-pound lateral load, a sufficient load for identifying broken spikes.

But the primary reason that NS added the NS 02 to its geometry car fleet is the mini load axle incorporated into the system. The NS 02's load axle (a scaled down version of the Gauge Restraint Measurement Systems (GRMS) used on the big 400-series TrackSTAR® units) applies a consistent 2,500-pound lateral load to the track — a force, NS has found, that is sufficient to find broken spikes that are difficult to identify by visual inspection.

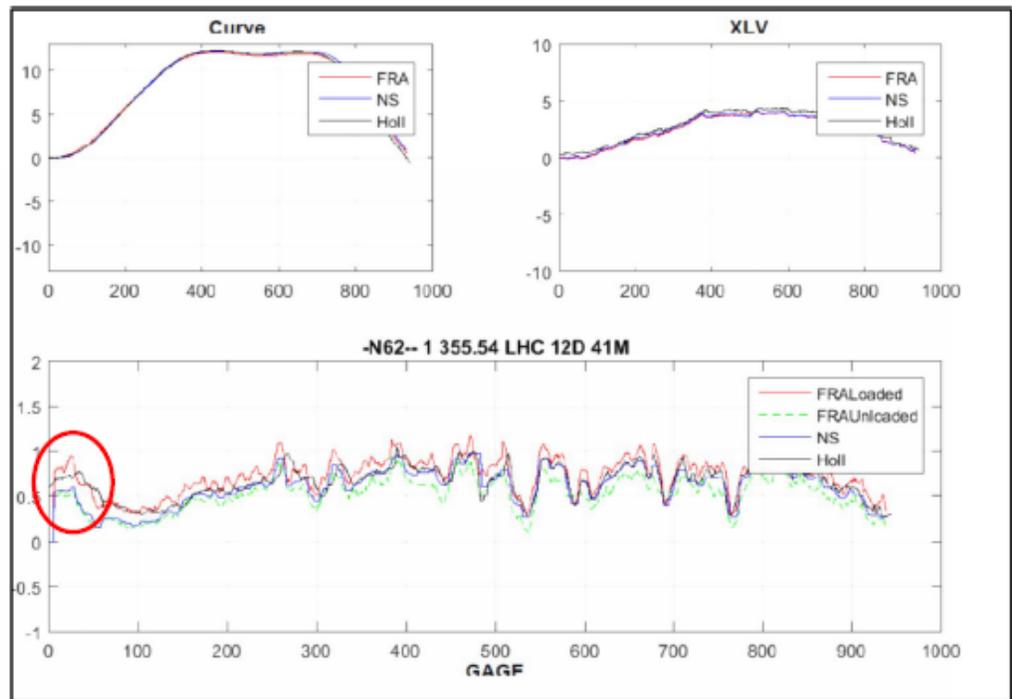
Gauge measurement data from NS 02 (shown in black) and NS 33 (shown in blue) are almost indistinguishable on curves. Measurements from the GRMS-equipped FRA car (which applies a 10,000-pound lateral load) (shown in red) is slightly wider. On tangent track, gauge is wider under the NS 02 than under NS 33 (red circle).

Before acquiring the NS 02 geometry truck, NS did due diligence on the effectiveness of the mini load axle. NS overlaid data from the Holland truck (NS 02) and NS 33 to see how the data from a hi-rail vehicle with a 2,500-pound axle load compared to the data from a railbound geometry car. As gauge widening — especially when gauge increases suddenly — is an indication of spike failure, NS paid particular attention to gauge measurements in curves.

“We found that the gauge measurements by the Holland truck were identical to those from our big car in curves,” Kerchof said. “As soon as I saw that I was sold. I’ve been waiting for 10 years for a truck like this.”

And since the load axle on the Holland-built NS 02 applies a constant lateral load on tangent as well as curved track, the NS 02 can also identify gauge widening on tangent track. “We see up to three-eighths of an inch of gauge-widening on tangent track with old ties,” Kerchof said.

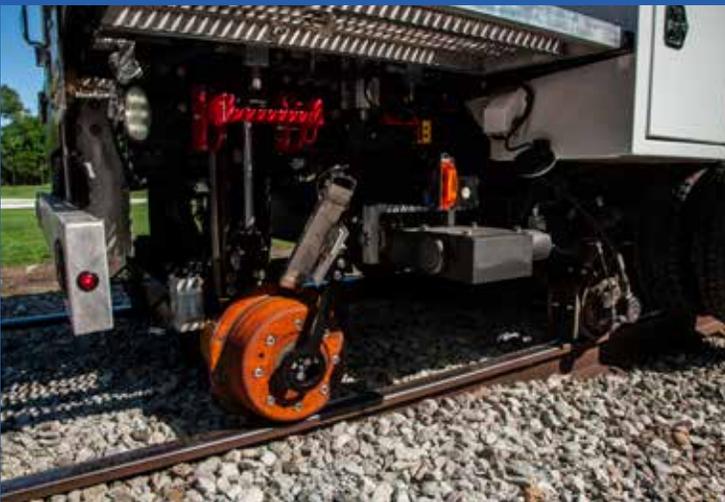
- locations where snow can interfere with the optical rail-measurement systems on the railbound cars. By virtue of its load axle, NS 02 can test in optical or contact mode, providing accurate gauge measurements in all conditions.

Track geometry and rail-wear data are entered into the same databases that are used by the railbound cars. Thus, data from the NS 02 assists with both local maintenance needs and system-wide planning.
