PROVING PERFORMANCE HANNE WELDED FROGS

THE BACKGROUND

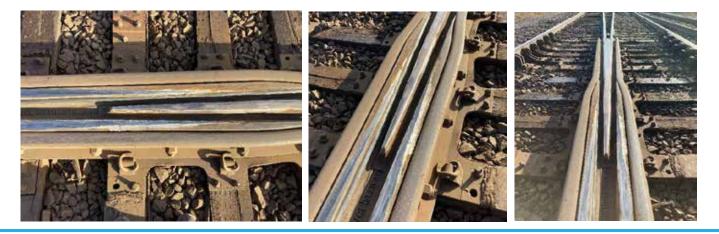
Date of repair	Serial #	Frog Type	Subdivision	Location	Track	Switch	-	Material Used lbs		Time in Service	MGT Rate per day	
5/3/2019	1502	RBM	GENEVA	CPY048	1	East	7	16.7	11/8/2022	1285.00	0.21	269.85

Condition: Fair. Some grinding on frog; Vertical crack; Riding good & even wear

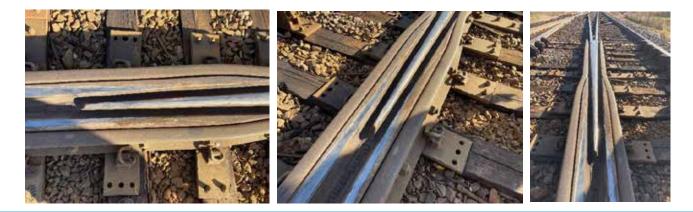
Date of repair	Serial #	Frog Type		Location	Track		-	Material Used lbs				
6/24/2019	1748	RBM	GENEVA	CPY055	2	West	5	19.88	11/8/2022	1233.00	0.15	184.95

Condition: Fair/Good. Cracking 10" back w/ flow; Riding good; Missing fasteners & broken tie plate.

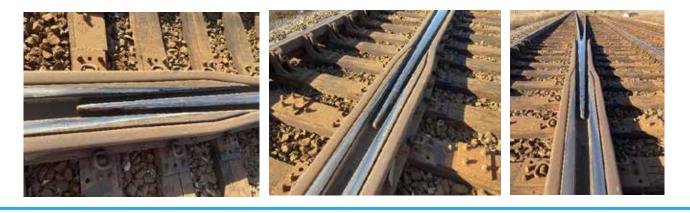
Date of repair	Serial #	Frog Type		Location	Track	Switch	Original Grade			Time in Service	MGT Rate per day	Est. MGT
7/3/2019	C1110107	RBM	GENEVA	CPY063	2	West	6	17.2	11/8/2022	1224.00	0.15	183.6

Condition: Fair/Good. Low points; Chipping; Riding good; Uniform wear

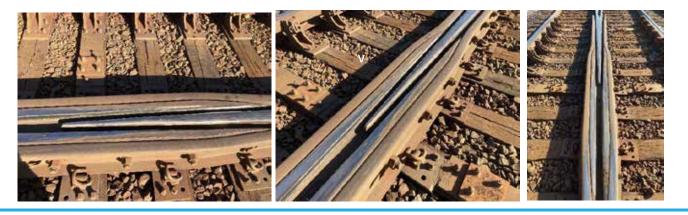
Date of repair	Serial #	Frog Type	Subdivision	Location	Track	Switch	_	Material Used lbs				
7/17/2019	1110/1270	RBM	GENEVA	CPY063	1	West	8	20.89	11/8/2022	1210.00	0.21	254.10

Condition: Very good. Slight cracking; Riding good

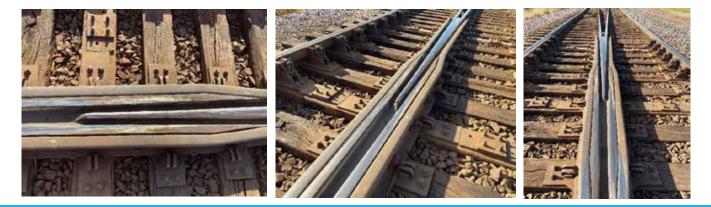
Date of repair	Serial #	Frog	Subdivision	Location	Track	Switch	U U		Service	Time in	MGT Rate	Est.
		Туре					Grade	Used lbs	Date	Service	per day	MGT
7/10/2019	300	RBM	GENEVA	CPY076	2		4	18.08	11/8/2022	1217.00	0.15	182.55

Condition: Good. Metal flow present, riding good.

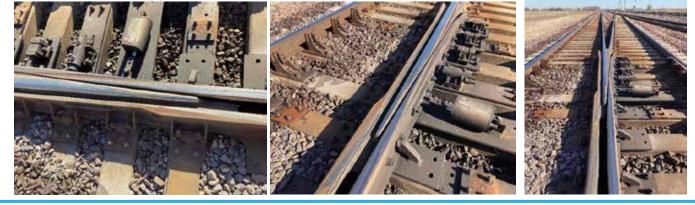
Date of repair	Serial #	Frog Type		Location	Track	Switch	•	Material Used lbs			MGT Rate per day	
7/19/2019	1110291	Spring	GENEVA	CPY078	1	West	2	6.11	11/8/2022	1208.00	0.21	253.68

Condition: Excellent. Riding good; Even wear

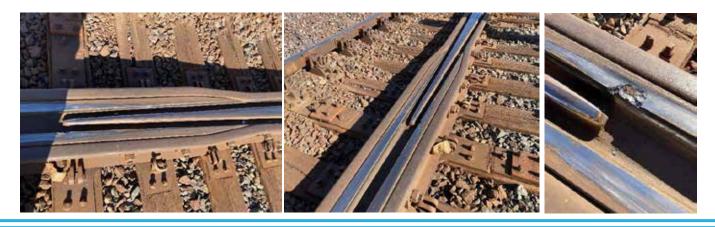
Date of repair	Serial #	Frog Type		Location	Track	•	Material Used lbs		Time in Service		Est. MGT
7/31/2019	464	RBM	GENEVA	CPY080	2	4	13.2	11/8/2022	1196.00	0.15	179.40

Condition: Good. Chip on mainline wing; Riding good.
