Using Reserve Gage Strength Data to
Enhance Tie-Replacement Planning

RMSS White Paper Series

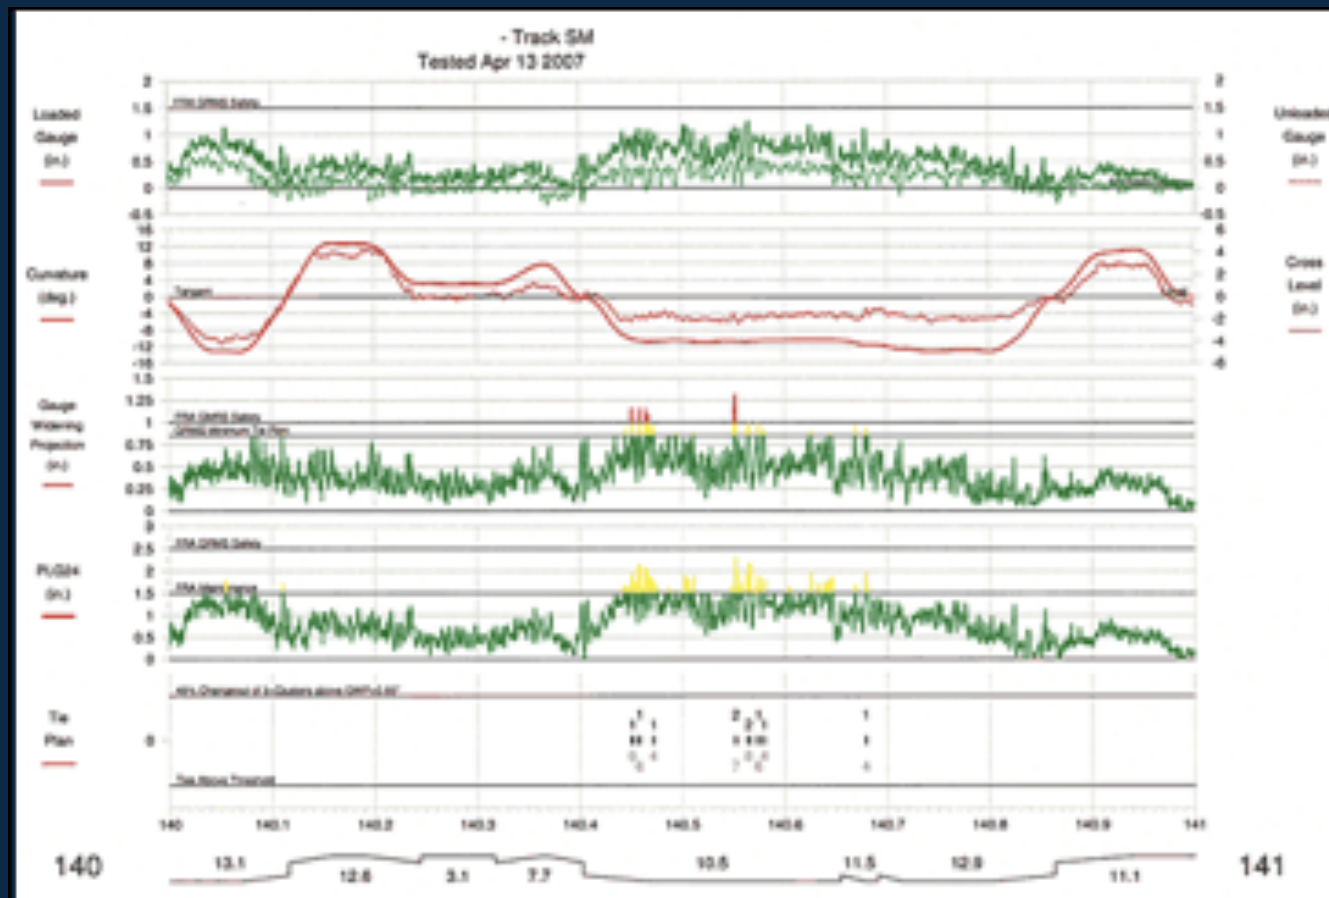
Figure 1a. Visual Tie Plan developed to improve track strength condition for one mile of Class 4 track. The thresholds are: $GWP > 0.85$ ", clusters of 4 or more consecutive ties exceeding the GWP threshold, and a replacement rate of 33% within clusters.

The key measurement for GRMS-based tie-replacement plans is “Gage Widening Projection” (GWP), an objective, performance-based measurement of the ability of ties and fasteners to hold gage. The strip chart shown in Figure 1a shows the measurements of unloaded and loaded gage, curvature and cross level, along with GWP and “Projected Loaded Gage” (PLG), which are GRMS measurements. The bottom line on the chart represents tie counts selected on the basis of the measured reserve gage-strength performance. This chart, generated by Holland’s Rangecam® software, is essentially a visual tie plan for one mile of track. The thresholds selected for this mile are: $GWP > 0.85$ ”, cluster lengths of 4 or more consecutive ties that exceed the GWP threshold, and an estimated replacement rate of 33% within the clusters that are found. This represents a plan that was developed to improve track strength with minimal tie replacement on a Class 4 track.

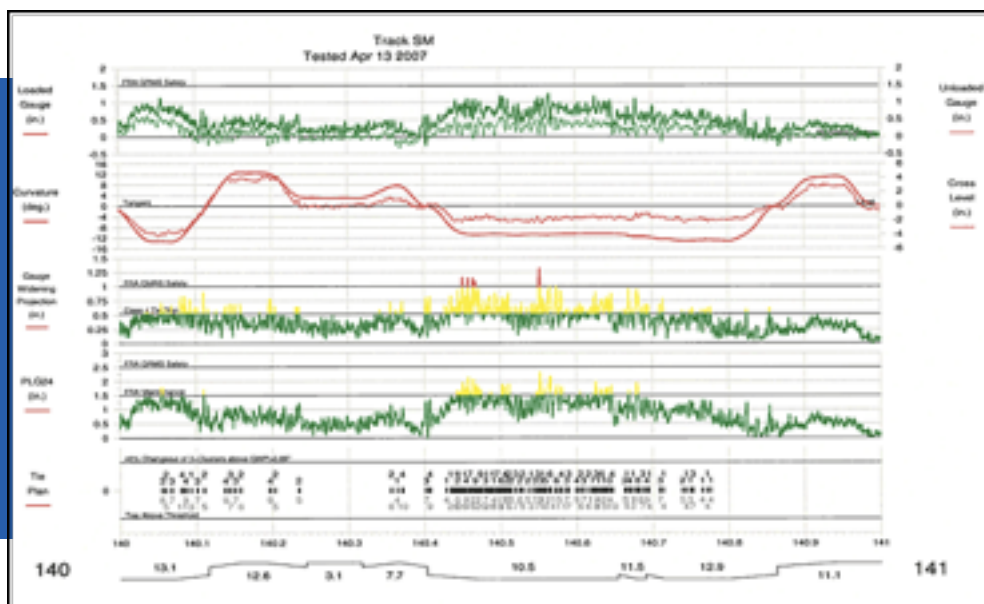
Figure 1b. This Visual Tie Plan was developed around the same mile of track shown in Figure 1a. The thresholds are: $GWP > 0.525$ ”, clusters of 3 or more ties, and a replacement rate of 45% within the clusters.

Figure 1b illustrates the same track with a major tie replacement plan. This visual tie plan was developed around the following parameters: $GWP > 0.525$ ” (which is well below the minimum safety standard), clusters of 3 or more ties (to focus in on short lengths of track that are weak), and a higher estimated replacement rate of 45% with the clusters. As expected, much more track requires replacement ties on the basis of the thresholds featured in figure 1b.

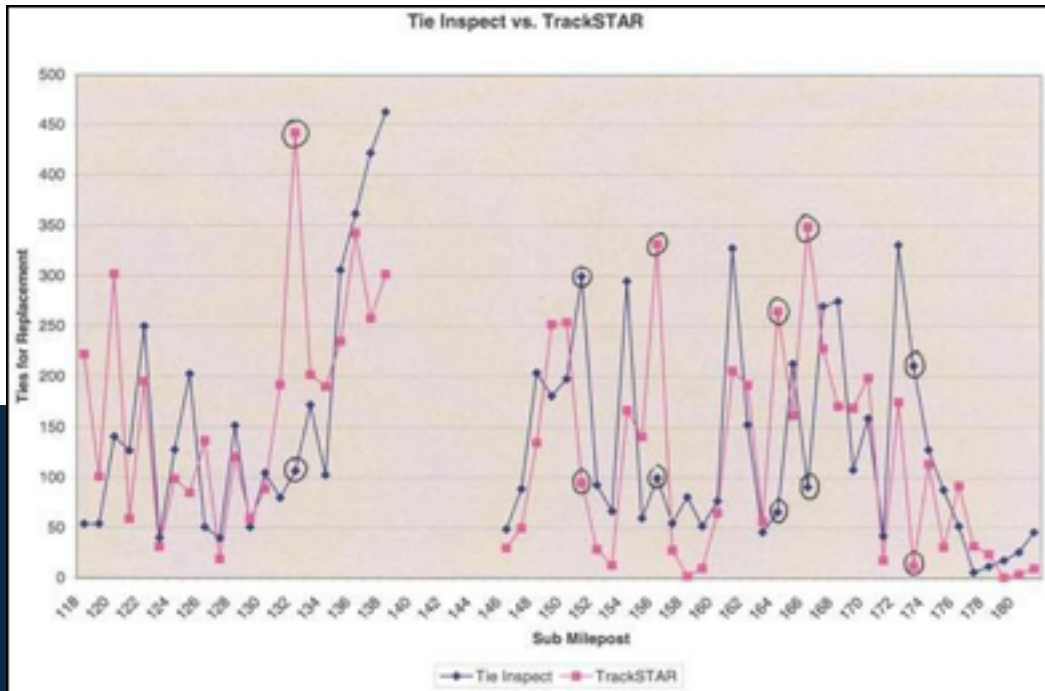
Figure 2. Visual inspection reports and performance-based GRMS data were compared for 57 miles of track.

Data was collected on 57 miles of class 3 and 4 track with curves of up to 6 degrees and annual tonnage of approximately 15 mgt. A cluster length of 4 or more consecutive ties, and 45% replacement logic was used for the comparison. A GWP threshold that matched the tie inspector's overall tie-replacement count of 7.981 ties was used to compare and evaluate the results. Figure 2 shows the 57 track miles in a mile-by-mile comparison. GRMS-based tie counts were very close to those of the visual inspector's tie counts over many miles. But they varied significantly within several miles.

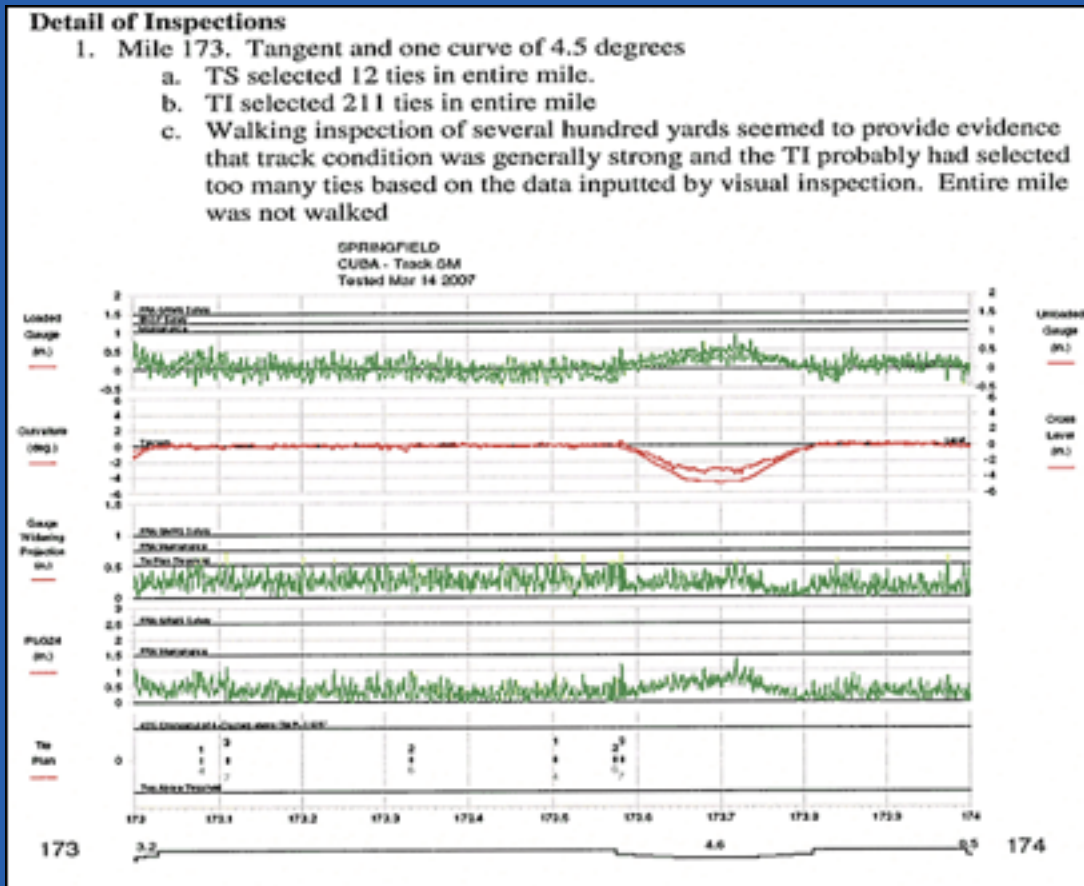
Figure 3a. Fifteen track segments were evaluated. Performance-based TrackSTAR® data (TS) generated by the GRMS system was compared to visually assessed condition, and tie counts generated by Zeta-Tech Associates, Inc.'s TieInspect® program to obtain detailed tie replacement count for the entire length of the track. The relatively low GWP indicates that the track is strong throughout most of the mile. The curve, which is stronger than the tangents, most likely had been recently maintained.

Fifteen track segments were inspected to sort out the differences. The data for mile 173 (shown in Figure 3a) indicates that the track is quite strong, based on the relatively low GWP readings throughout most of the mile. (“TS” represents performance-based TrackSTAR® data generated by the GRMS system. “TI” represents the visually assessed condition, and tie counts generated by the TieInspect® program.) The chief tie inspector concluded that although this section of track exhibited excellent reserve gage strength, tie inspectors tend to alter their grading standards when they have walked long lengths of track without classifying ties as “failed” or “weak.” This might have accounted for part of the 211 ties selected by the visually based method.

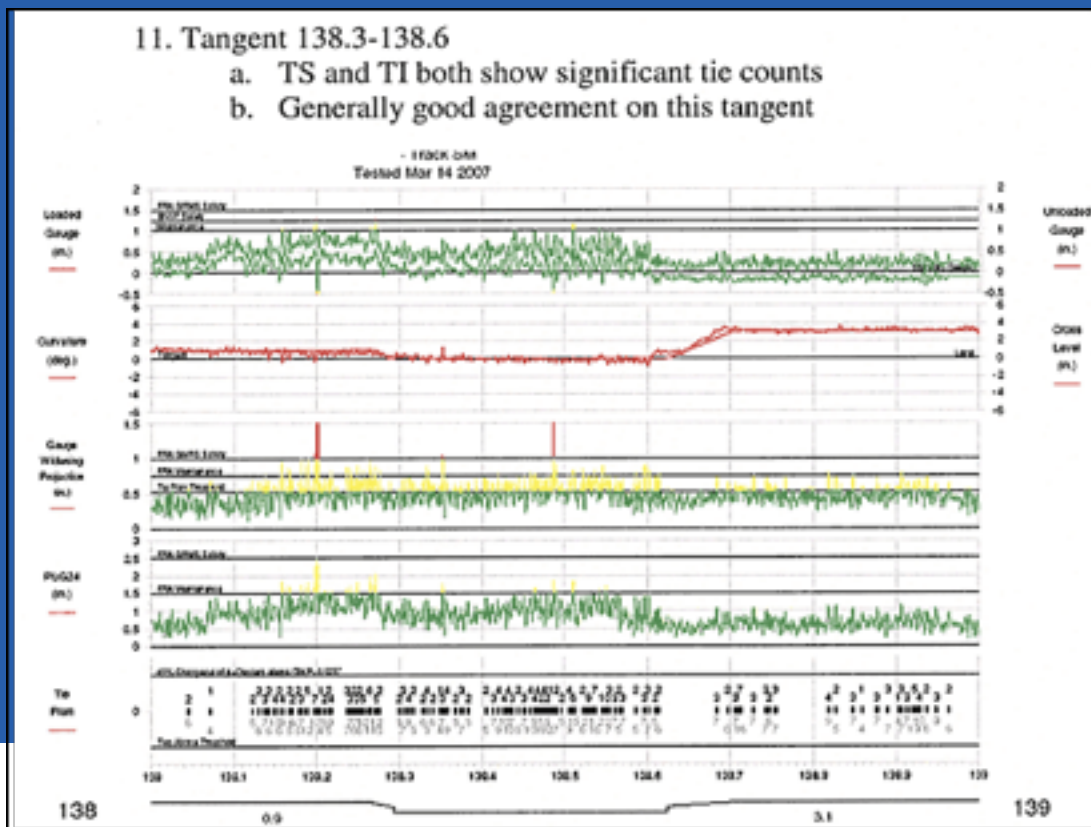
Figure 3b. A walking inspection of the entire length of the tangent between MP 138.3 and 138.6 yielded good agreement on tie counts between the visual inspection and the performance-based assessment. The 3-degree curve beginning at 138.6 is stronger than the preceding tangent and one-degree curve, indicating that it had been maintained prior to the inspection.

A walking inspection was performed on the entire length of the tangent section at Site 11, between MP 138.3 and 138.6 (see Figure 3b). As the Figure indicates, there was good agreement on tie counts between the visual inspection and the performance-based assessment. The Figure shows that there was a lot of weak track in this tangent segment. The 3-degree curve beginning at 138.6 is clearly stronger than the preceding tangent and 1-degree curve, indicating that the 3-degree curve had undergone maintenance prior to the inspection.

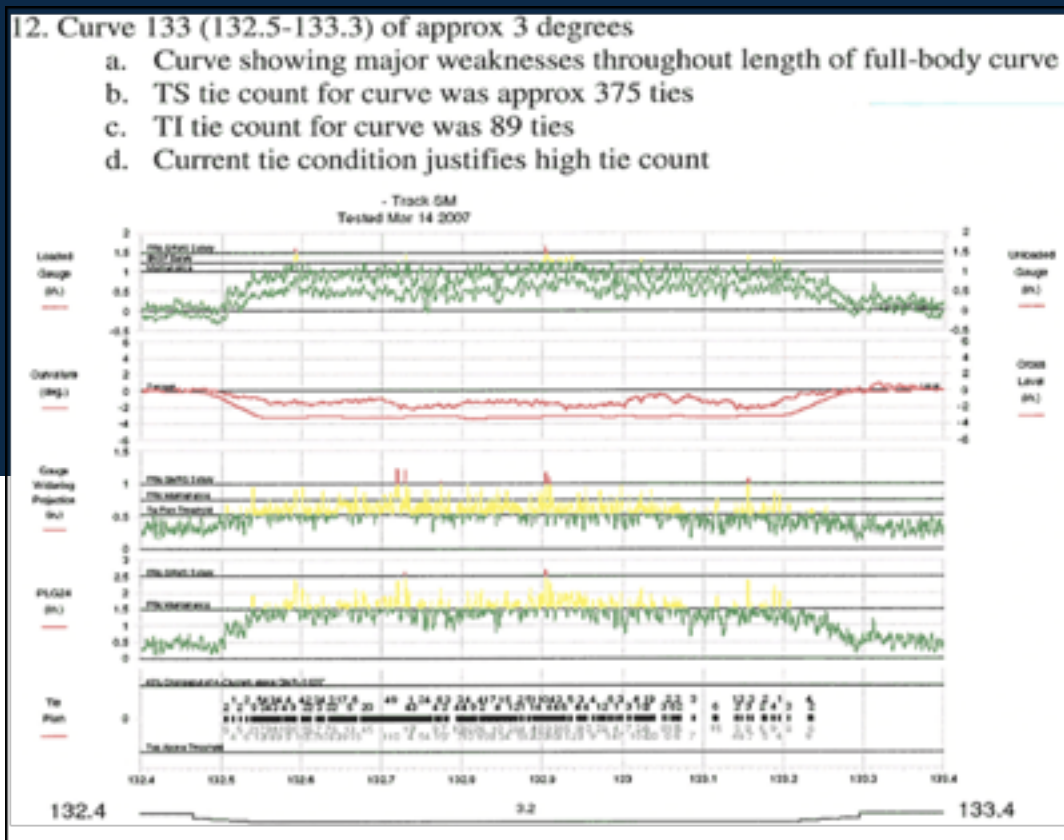
Figure 3c. The GRMS, performance-based assessment selected 375 ties for replacement in this approximately 3/4-mile curve, compared to 89 ties selected by the standard, visual-inspection method. A walking inspection by the chief tie inspector agreed that the performance-based tie count was much closer to what was actually required.

The 3-degree curve at site 12 was also chosen for further inspection because there were significantly different tie counts produced by the two methods (see Figure 3c). After a follow up walking inspection of the entire curve, the chief tie inspector agreed that the GRMS, performance-based tie count at 375 ties was much closer to what was actually required than the 89 ties counted by the standard, visual method.
