Holland[®] LASERWELDER

A NEW STANDARD FOR SAFER, LONGER LASTING REPAIRS

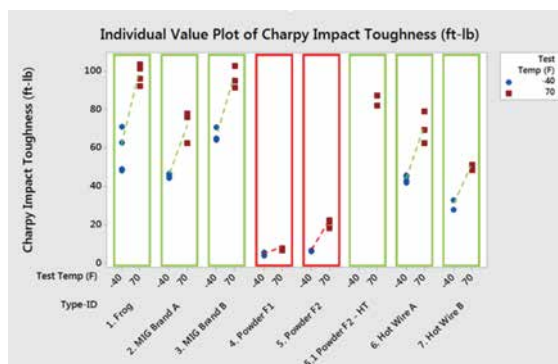
Charpy Impact – Hot Wire equivalent to MIG

Holland, with support from Union Pacific and Evraz, performed comparative material tests to validate Hot Wire Laser Welding technology. Key tests chosen for evaluation were Charpy impact, tensile, disc-on-disc wear, hardness, work hardening and heat input. Hot wire laser welding produced equivalent characteristics to standard MIG welding manganese and base frog material. See AREMA paper presented at the Fall 2018 meeting. Figures below show some of these comparative results.

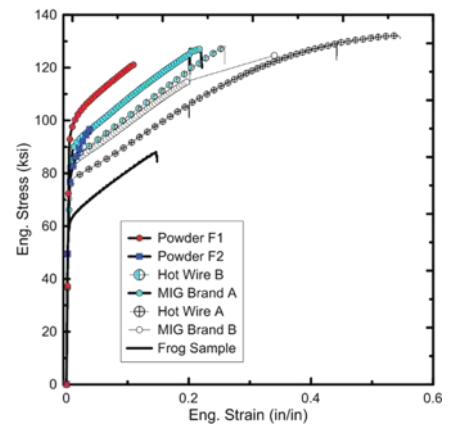
Tensile Testing – Exceeds MIG welding performance

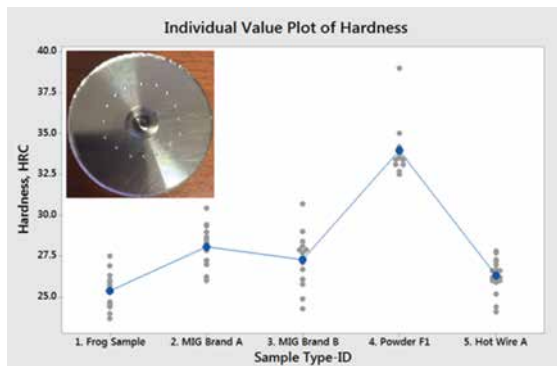
Initial Hardness – Equivalent to MIG and Base

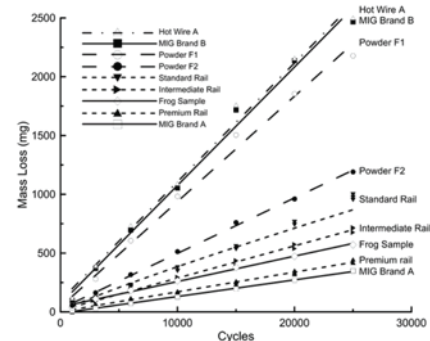
Wear test equivalent to MIG welding

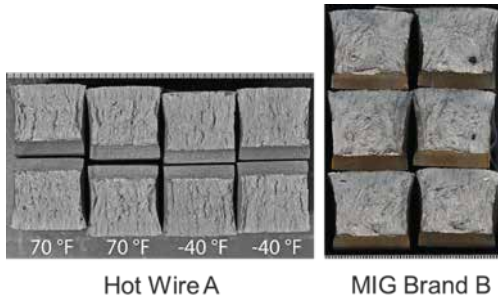
Laser Welding shows significantly less porosity

Laser welding key benefits are lower heat input to base material allowing faster welding at the same time keeping base material below 500 degrees F. Robotically welded using laser technology produces significantly lower porosity with inter-pass layers. Both are key characteristics providing a longer life to the repair. See cross-sectional view of material build up.

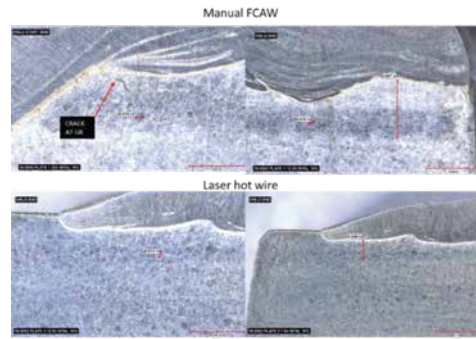
Lower heat input is clear from grain growth and no microcracking

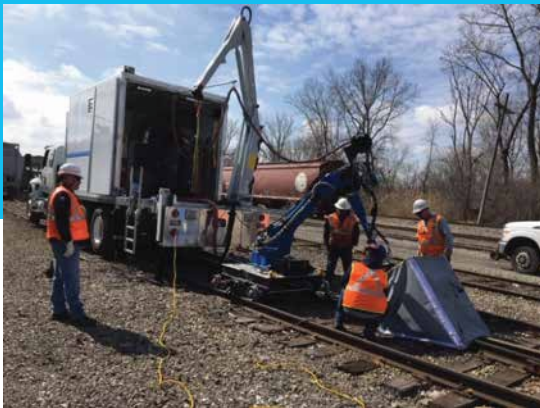
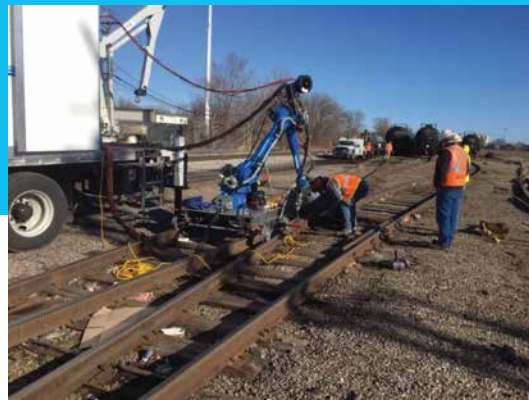
Holland's LaserWelder™ design provides the ability to weld on track or beside track.
