**Holland**[®]
LaserWelder[™]

PROVING PERFORMANCE
LASER WELDED
FROGS

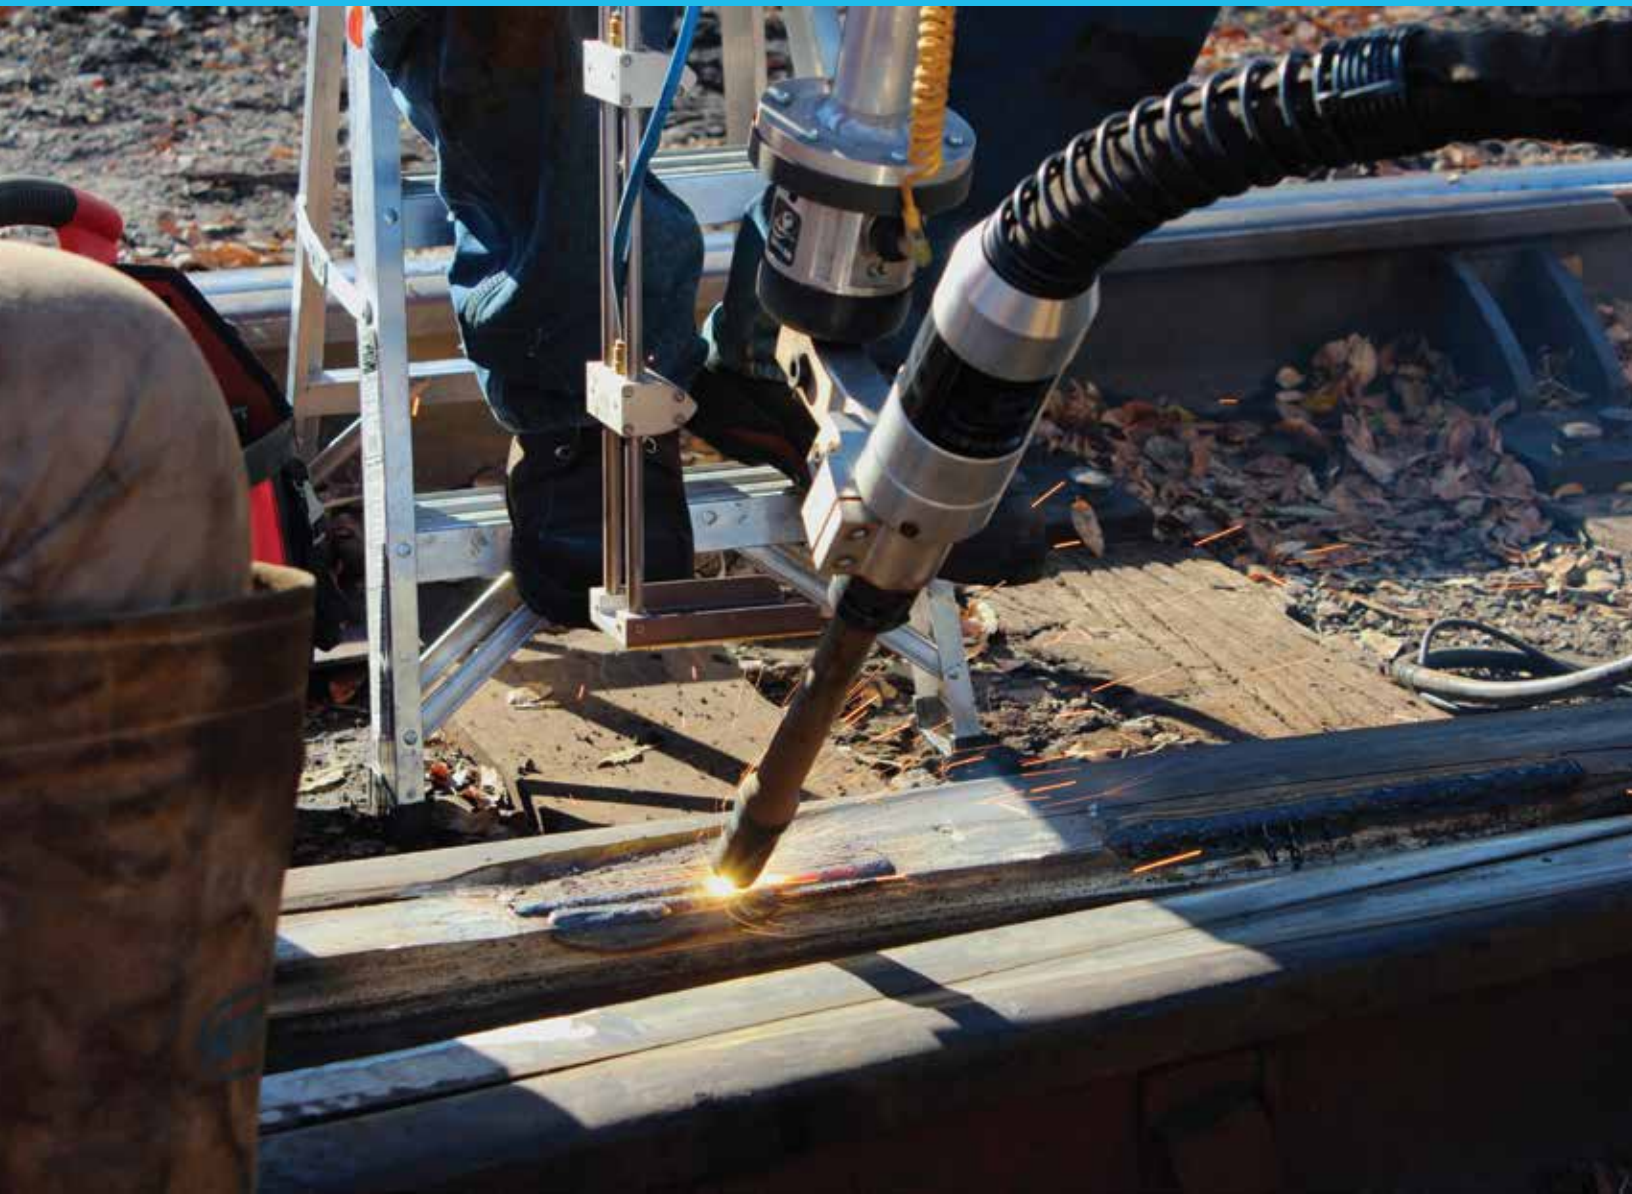
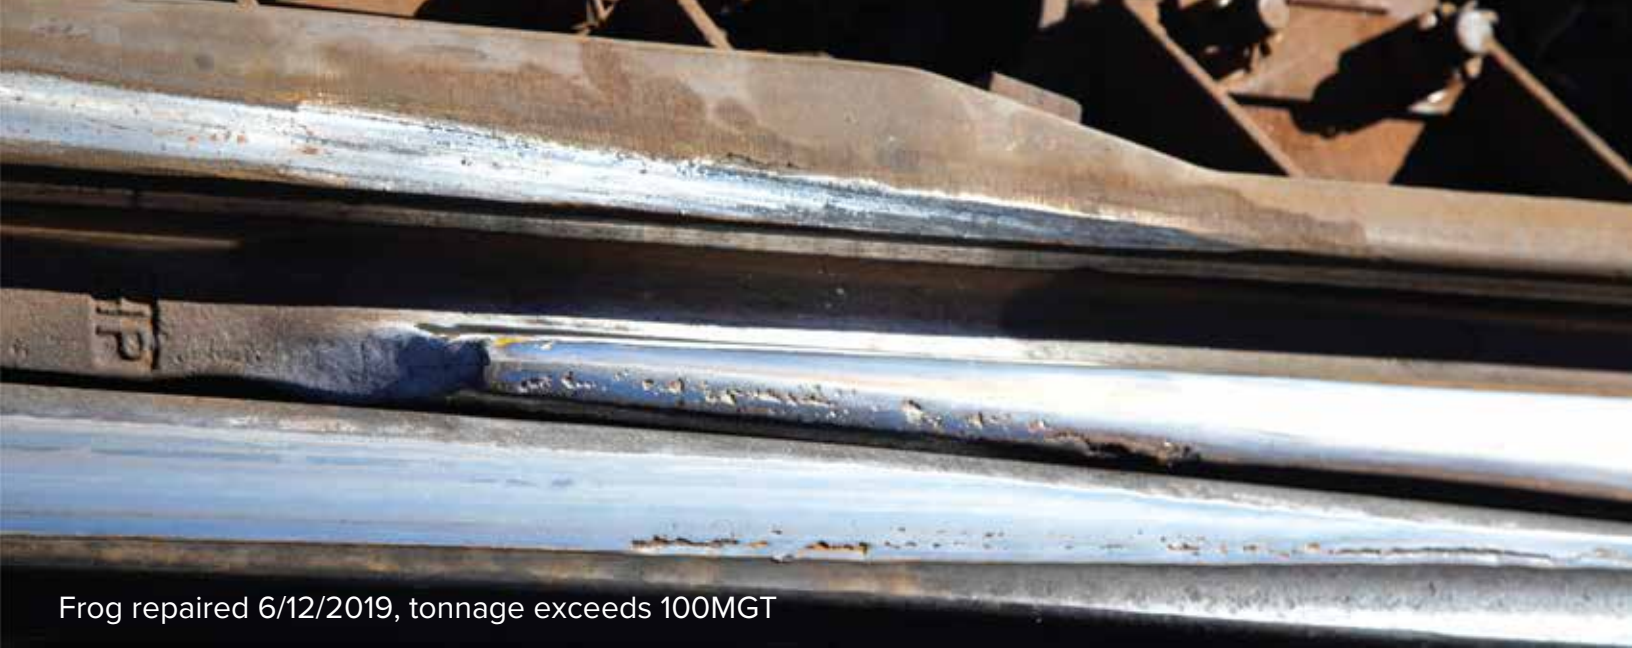
Frog repaired 6/12/2019, tonnage exceeds 100MGT

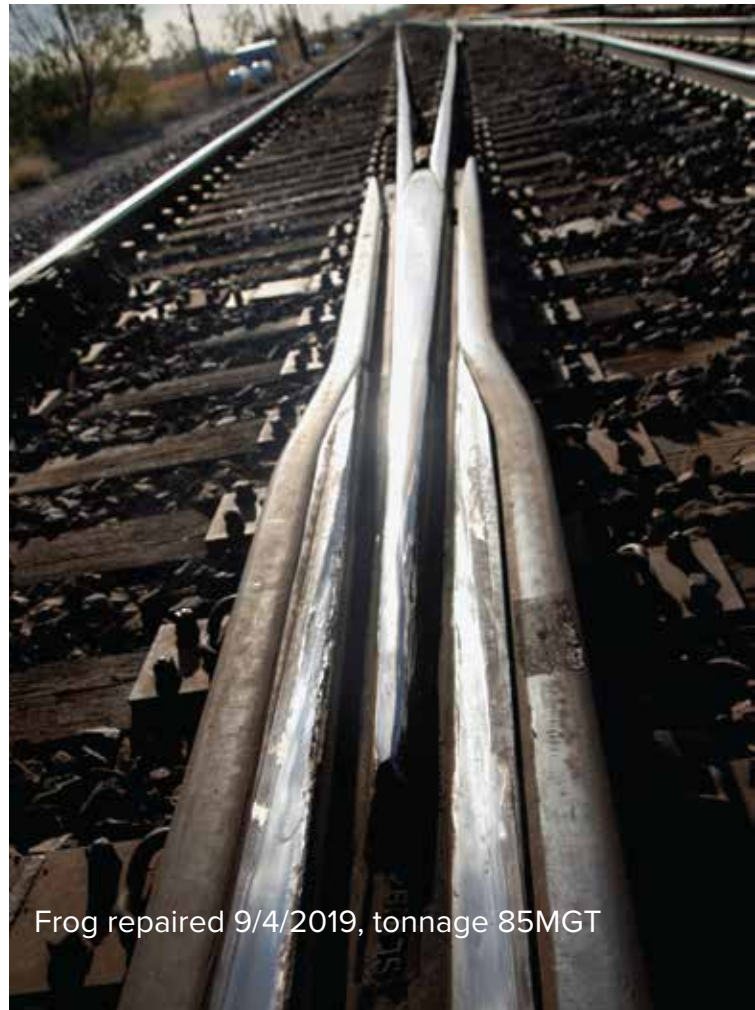
Frog repaired 9/4/2019, tonnage 85MGT
